Technical Report CERC-93-14
August 1993

Revetment Stability Tests for Sargent Beach, Texas

Prepared for U.S. Army Engineer District, Galveston

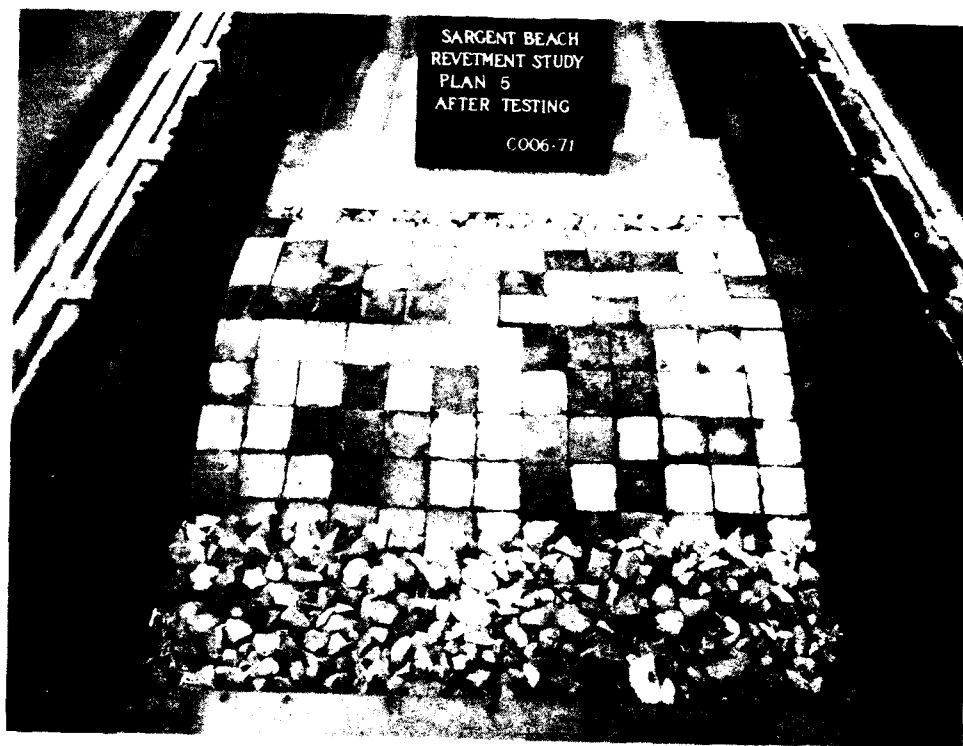
Photo 17. Side view of Plan 5 after wave attack

Photo 18. Sea-side view of Plan 5 after wave attack

Plan 5 (Figure 8) was similar to Plan 4 except it was assumed that the erosion depth in front of the structure was 5 ft less (sea bottom was raised from -8.6 ft mlt to -3.6 ft mlt). Also, the upper toe elevation was raised from -5.0 ft mlt to -3.6 ft mlt. Plan 5 was subjected to the same 24-step test as Plan 1 (Table 1). Testing at the +4-ft swl produced no movement of the concrete blocks. A few of the smaller 200- to 2,000-lb shore-side crest stones were displaced. Two additional crest stones were displaced during continued testing at the +7-, +9.5-, and +14-ft swl's. No movement of the concrete blocks could be detected at any of the swl's. Photos 17 and 18 show the structure after wave attack.
